SIMPLIFIED FOREST STAND DELINEATION PLANS
OF
PRIMROSE HILL
3 MILKSHAKE LANE
TAX MAP 51I, GRID 4, PARCEL 319
CITY OF ANNAPOLIS, MARYLAND
SIXTH DISTRICT ANNE ARUNDEL COUNTY ZONED R2

Date: JAN 2013										FSD TREE ASSESSMENT TABLE										Project: PRIMROSE HILL	
Tree #	DBH	Common Name	Botanical Name	Age Estimate	Condition Rating %	Condition Rating	Approx Canopy Radius (FT)	CRZ Critical Root Zone Radius in FT (1.5 x maximum DBH)	Priority for Preservation (1-4)	Additional Notes	Condition Notes										
	(Diameter at 4.5 feet above grade)																				
2	52	beech, European	<i>Fagus sylvatica</i>	111	63	Fair	45	78	1	Damaged, rotting trunk; copper cultivar, significant upper crown decline in 1 half, needs restoration	Large DW (3+*), Trunk Decay, Broken Limbs, Mechanical Damage,										
3	42	pecan	<i>Carya illinoensis</i>	105	67	Fair	40	63	2	prune, air layered limb, large trunk decay on declining side, english ivy at base, frass, large broken leader (14")	Large DW (3+*), Broken Limbs, Vines,										
4	36	pecan	<i>Carya illinoensis</i>	90	53	Fair	28	54	2	Trunk cavity at base, further inspection required	One Sided, Trunk Decay, Basal Decay,

PRIMROSE HILL
ANNAPOLIS, MARYLAND

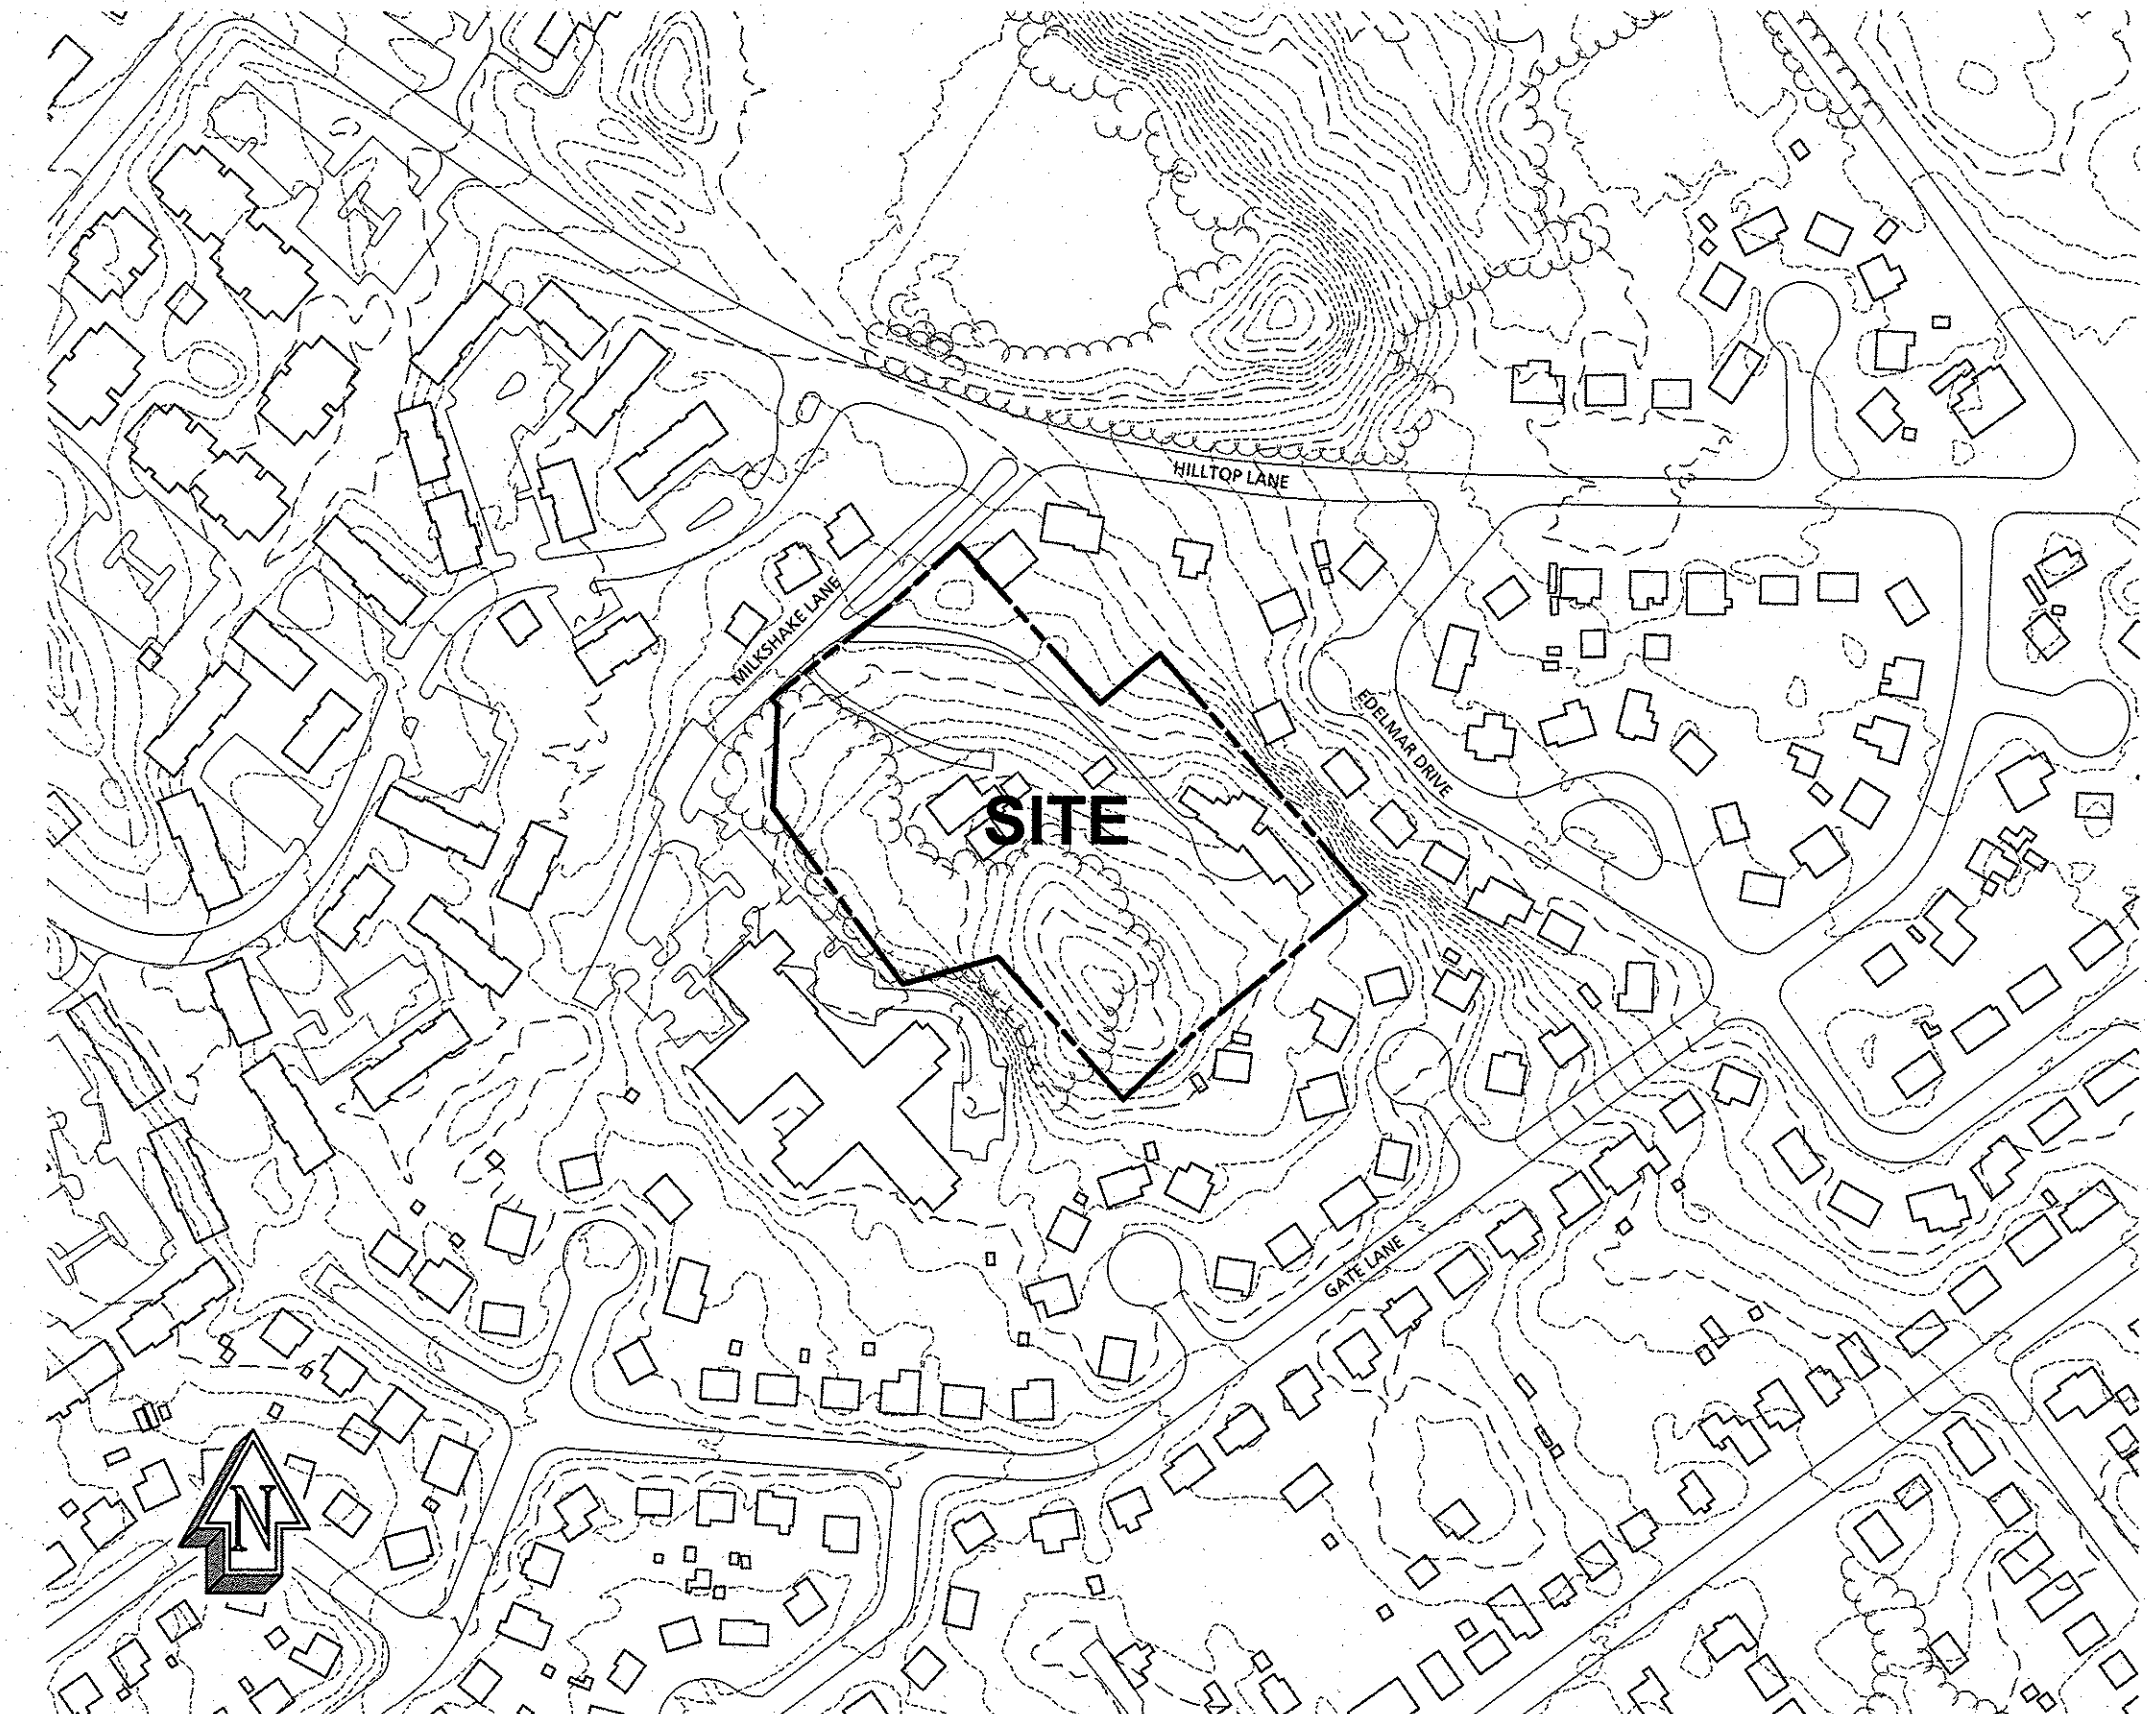
G. THE PROPERTY CONTAINS TEN (10) SPECIMEN TREES (DBH ≥ 30"), OF WHICH TWO (2) WERE DETERMINED TO BE IN POOR CONDITION.

- NOTES:
1. ONLY TREES >24" DBH AND TREES THAT MAY BE 50 YEARS OR OLDER WITHIN THE HISTORIC AREA ARE DEPICTED ON THE FSD.
* 2. TREES #25 AND #29 CLASSIFIED AS "FAIR" BY DAVEY RESOURCE GROUP AND CHANGED TO "GOOD" PER DNEP REQUEST IN A LETTER DATED 3-4-13 FROM FRANK BIBA TO BAY ENGINEERING INC.
